EPA/600/R-10/169 | December 2010 | www.epa.gov/ord

Compatibility of Material and Electronic Equipment With Hydrogen Peroxide and Chlorine Dioxide Fumigation

ASSESSMENT AND EVALUATION REPORT

Office of Research and Development
National Homeland Security Research Center

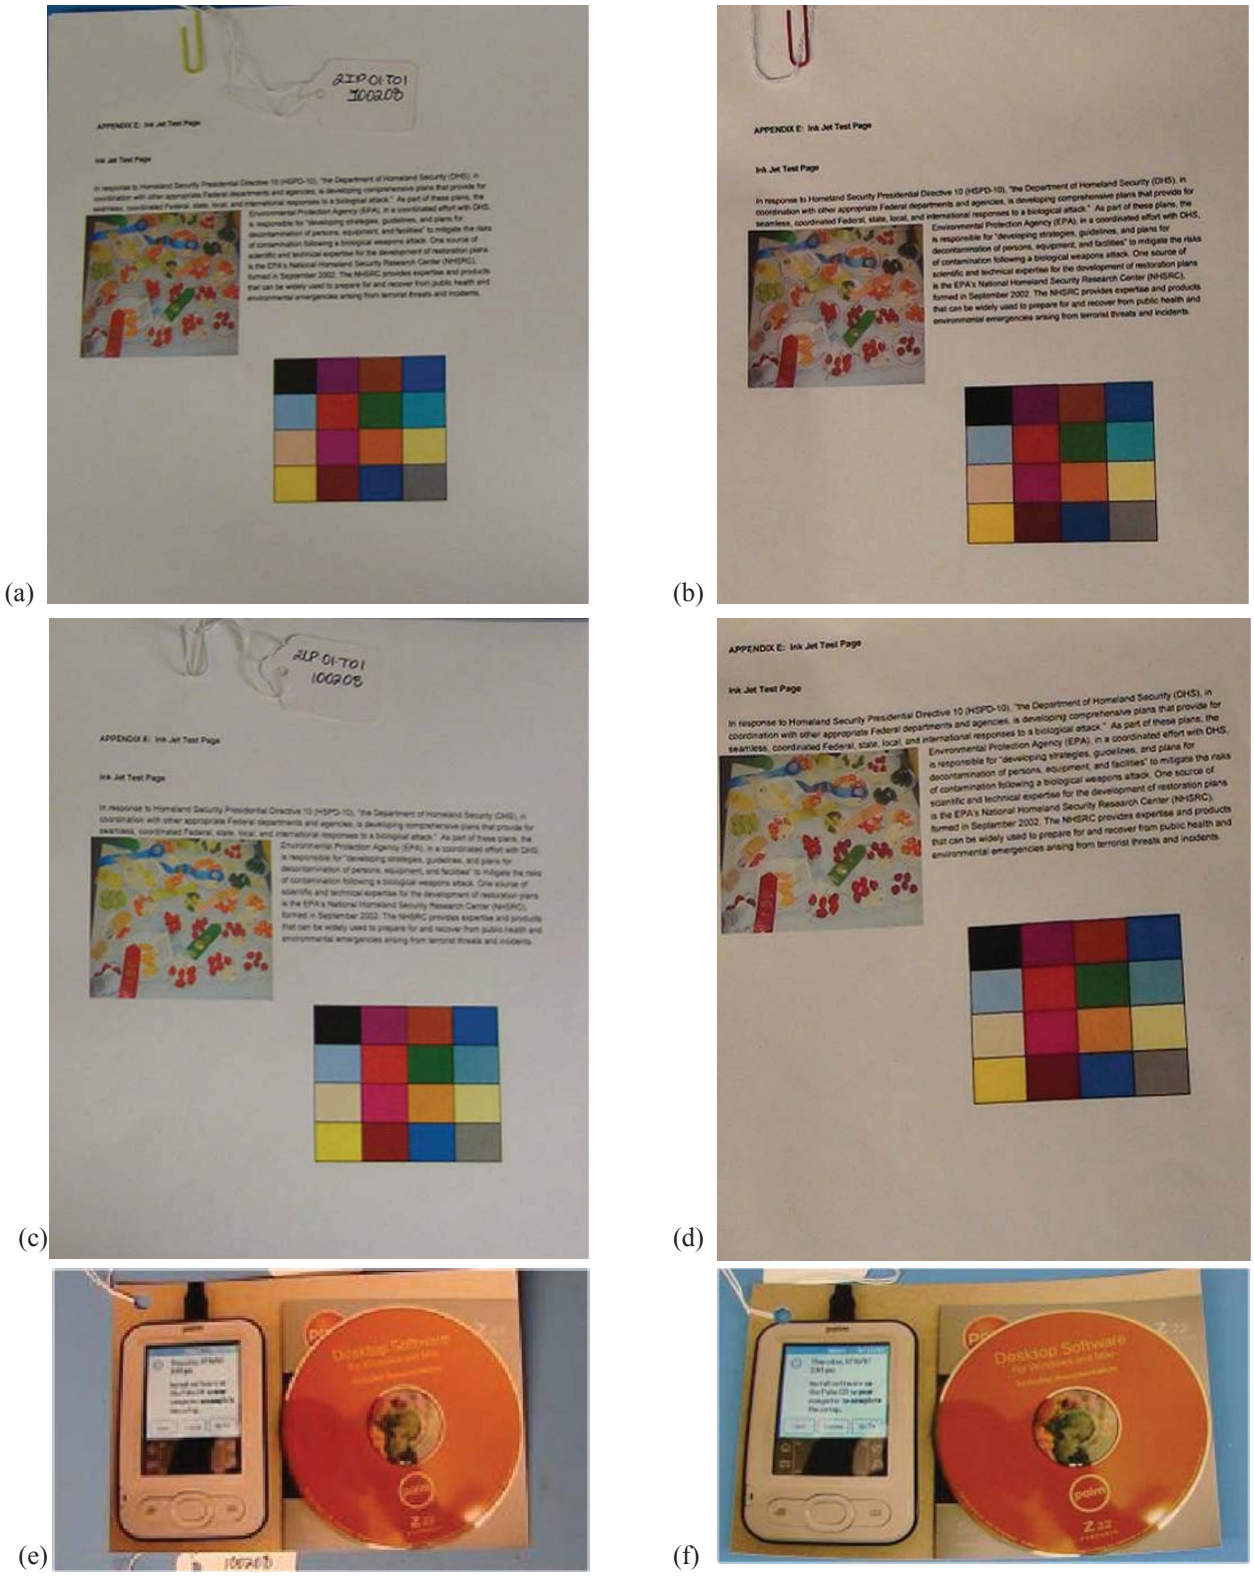
Figure 4-1 shows the original Inkjet printed paper (a) before and (b) one year after being exposed to BioQuell HPV fumigation with a starting RH of 35% (test run R01). Similar photos are shown for laser printed paper (c) before and (d) one year after, and color printed photographs (e) before and (f) one year after BioQuell HPV fumigation with a higher starting RH of 65% (test run R02).

These results are typical for all six fumigation conditions studied with both BioQuell HPV and STERIS VHP fumigation technologies. The printed paper and photographs for each fumigation condition remained visibly unchanged throughout the 12-month post fumigation observation period. Color pigments do not appear to be adversely affected by exposure to vaporized H_2O_2 at either high or low concentrations or RH levels. In addition, extending the duration of the H_2O_2 exposure by 1.5x (test run R04) had no impact on these Category 2 materials.

Figure 4-1. Inkjet printed paper (a) before and (b) 12 months after HPV fumigation (R01). Laser printed paper (c) before and (d) 12 months after HPV fumigation at higher initial RH (R02). Glossy 5"x 6" color photographs (e) before and (f) 12 months after HPV fumigation at higher initial RH (R02).

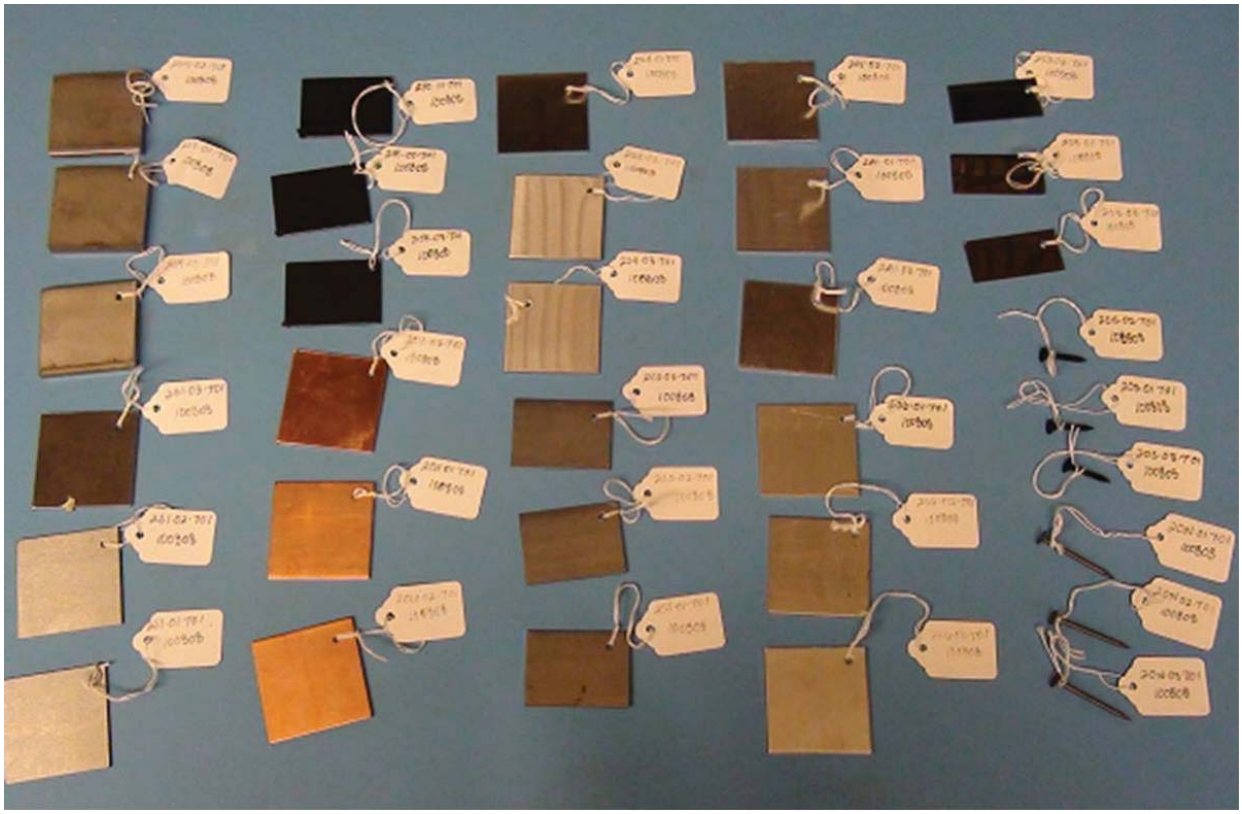
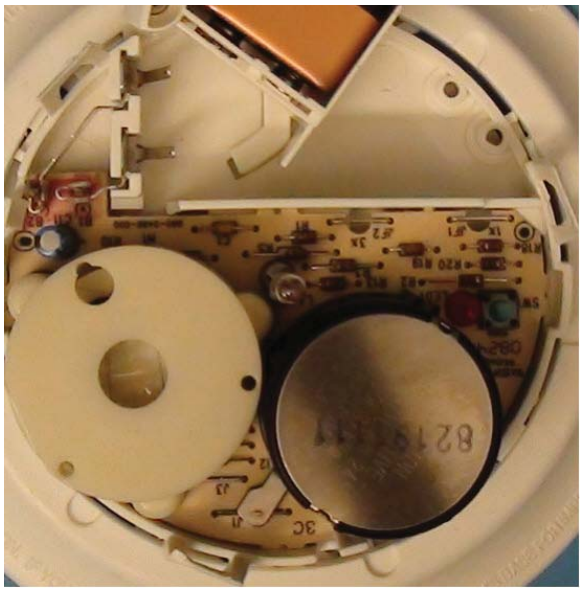
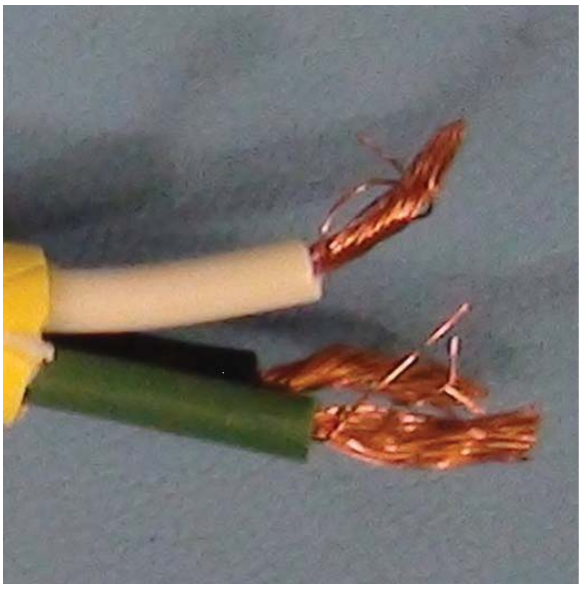
Vaporized H_2O_2 exposure showed no caustic effects on the other Category 2 materials tested under any of the test conditions. Figure 4-2(a) shows that each set of metals remained tarnish free, with no signs of rust or corrosion. Each exposed smoke detector remained fully operational throughout the year after exposure; the battery terminals, resistors, and other components showed no signs of physical damage as seen in Figure 4-2 (b). Figure 4-2 (c) shows that the exposed stranded wires remained tarnish free for 12 months after exposure. These results were typical for each of the six fumigation conditions.

Figure 4-2. (a) Category 2 metals, (b) Inside of a smoke detector, and (c) exposed wire of stranded wire 12 months after H_2O_2 fumigation.

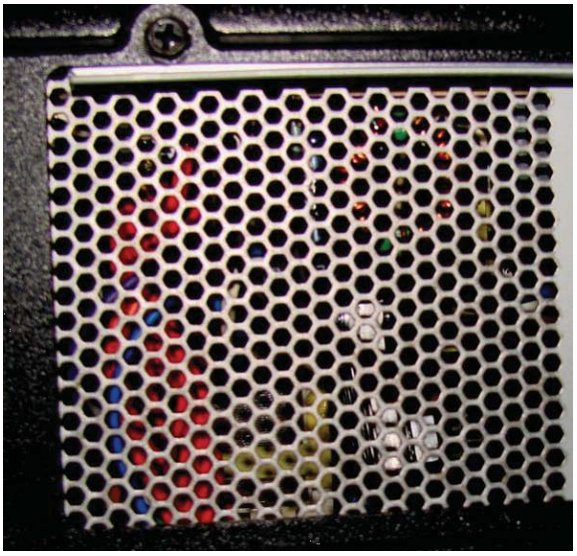
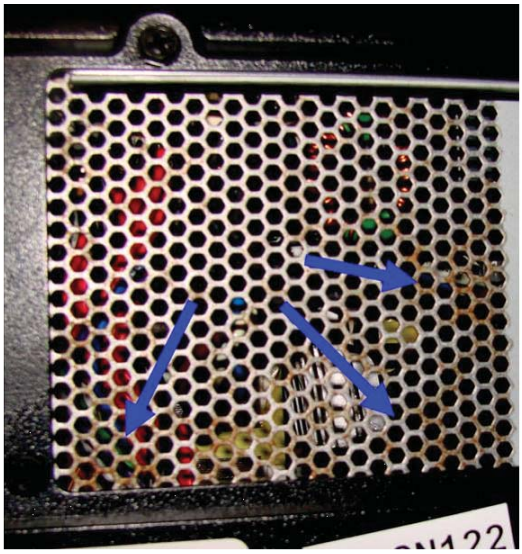
Figure 4-6. Comparison of the top metal grid on the back of tested computers. The computer in (a) was fumigated at 3000 ppmv for 3 hours and shows little corrosion. Computer (b) was fumigated at 750 ppmv for 12 hours. Blue arrows indicate selected areas of signi cant corrosion.

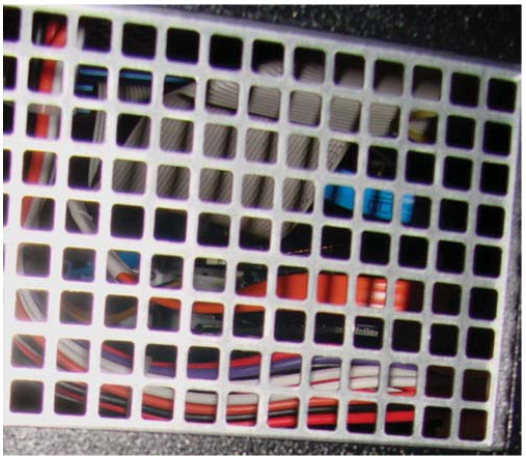
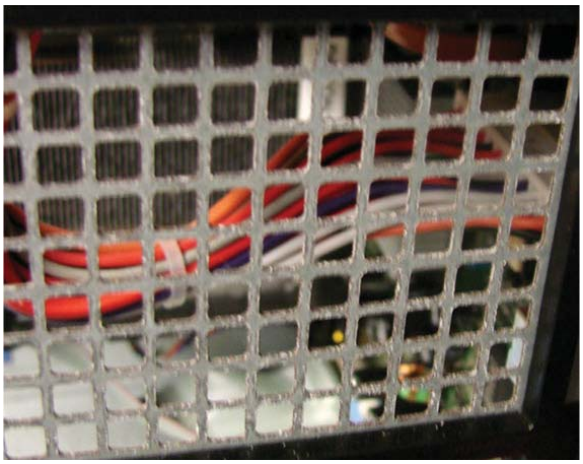
Figure 4-7. Central grid on the backs of computers not exposed (a) and exposed (b) to 750 ppmv ClO_2. The corrosion is visible as a white powdery crust along the edges of the holes in the grid.

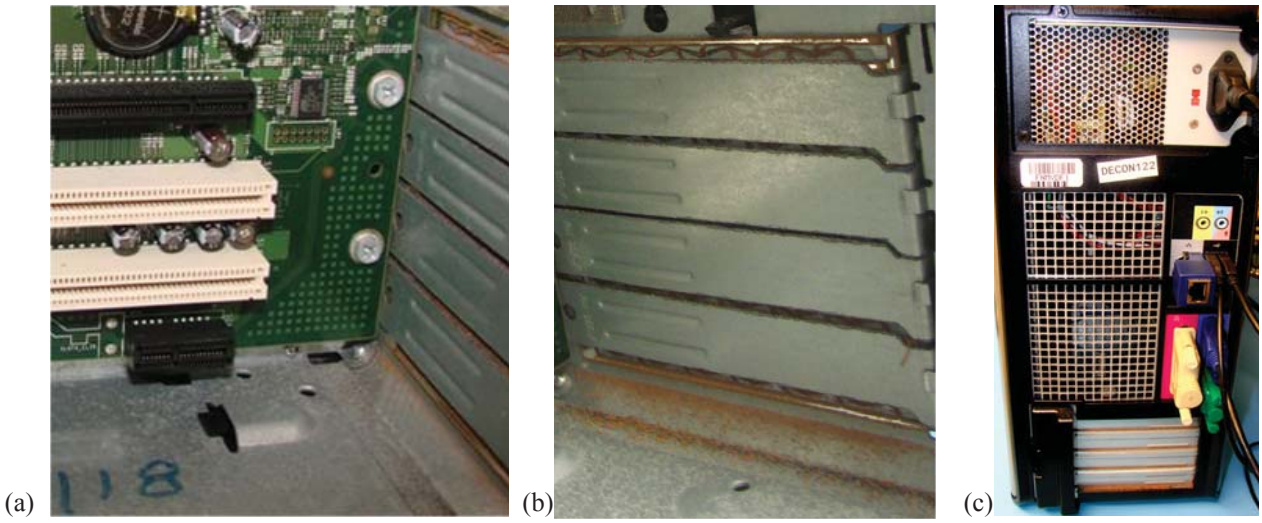
Figure 4-8. Corrosion of PCI slot covers exposed to ClO_2 in (a) 3000 ppmv and (b) 750 ppmv fumigations. Also evident in (c) is corrosion of the metal grids covering the back of the computer.

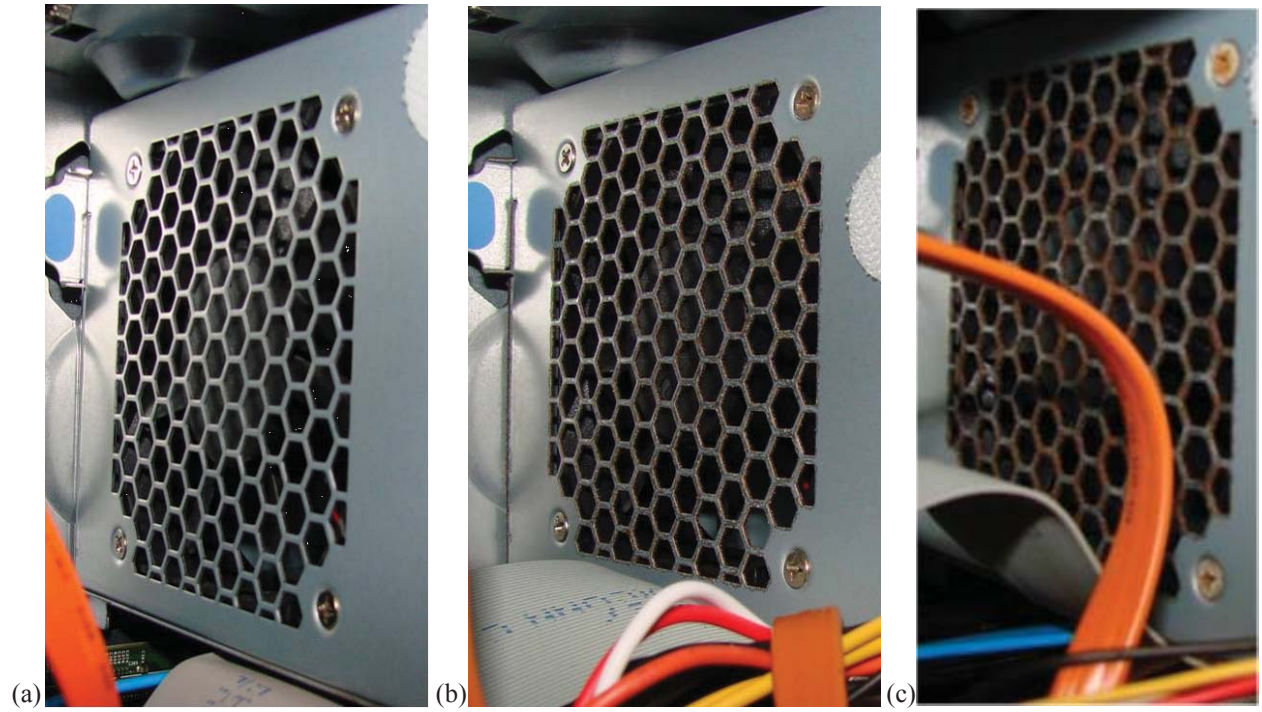
Figure 4-9 shows an unexposed power supply case grid (a) and similar corrosion found on computer grids exposed to (b) 3000 ppmv and (c) 750 ppmv ClO_2. Again, more extensive corrosion is evident in the longer 750 ppmv exposed computer. For the 3000 ppmv exposed computers, the grids appeared similar, whether they were active or idle during the fumigation.

Figure 4-9. An unexposed power supply case with no corrosion (a) compared to a corroded grid seen on computers fumigated with ClO_2 at (b) 3000 ppmv and (c) 750 ppmv.

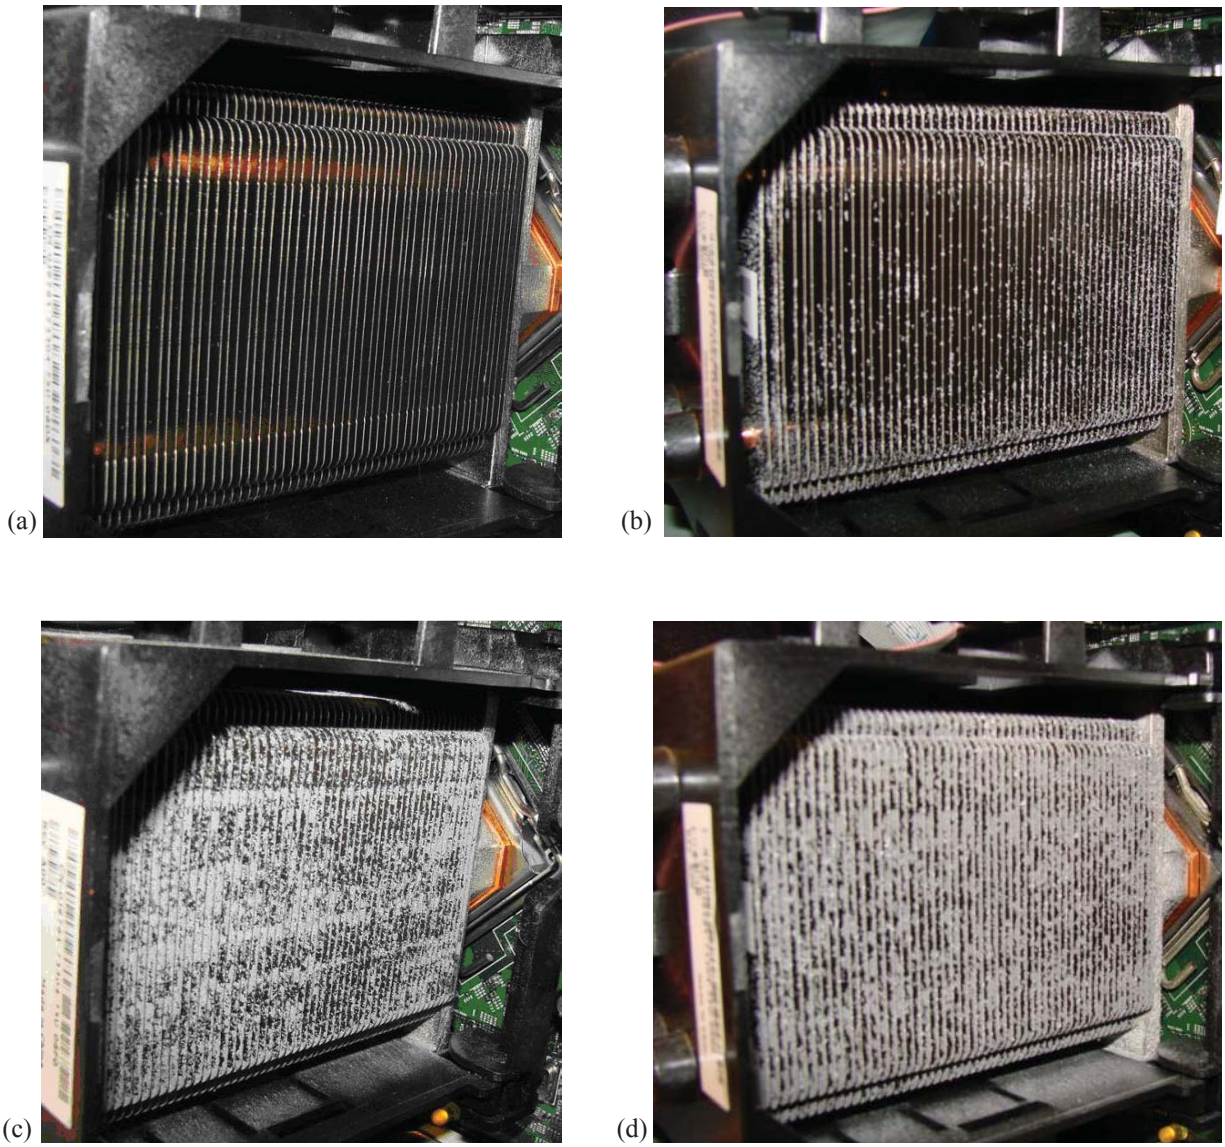
Other corrosion was evident, in the form of a white powder, on the central processing unit (CPU) heat sink in ClO_2 exposed computers. Figure 4-10 shows the range of corrosion seen on the CPU heat sink as compared to an unaffected heat sink (a). Figure 4-10(b) shows much less corrosion in a 3000 ppmv computer that was ON and active, as opposed to the 3000 ppmv computer that was powered ON and idle (c). The most widespread and serious corrosion was seen on the 750 ppmv computer (d) that was On and idle, and exposed to ClO_2 for 12 hours.

Most, if not all, of the corrosion in the ClO_2 exposed computers appears to be originating on the CPU heat sink. When computers were ON and active, the fan helped blow the dust off the CPU itself. Figures 4-10(b) and (c) clearly show the difference between computers that were active (b) versus idle (c).

Figure 4-10. (a) A computer CPU heat sink not exposed to ClO_2. Moderate corrosion on 3000 ppmv computer that was ON and active (b), compared to severe corrosion seen when ON and idle (c). Widespread, severe corrosion on the 750 ppmv exposed computer (d).

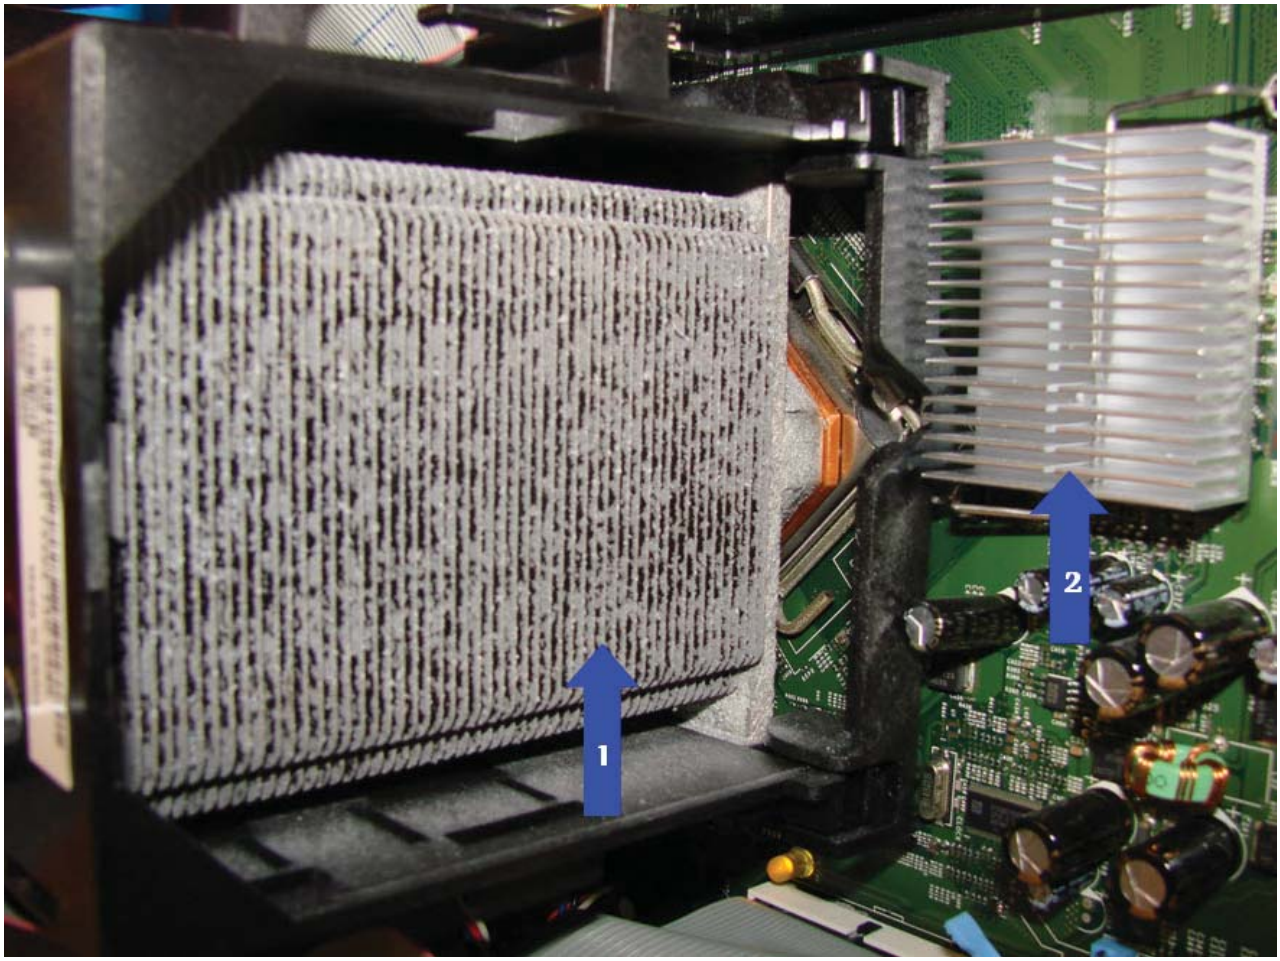
Figure 4-11 shows one signi cant internal item of note: the graphics processing unit (GPU) heat sink remained unaffected in the same computers that demonstrated corrosion of the CPU heat sink. This observation matches previous research results of exposure to chlorine dioxide[17] and was discussed by Alcatel-Lucent[15] in their CBRTA report as being due to the different metallic compositions of the two heat sinks. The CPU heat sink consists of an aluminum alloy with a nickel-phosphorus coating which can experience galvanic corrosion, while the GPU heat sink is simply a single aluminum alloy.

Figure 4-11. Computer heat sinks after exposure to ClO_2. Arrow 1 points to the CPU heat sink, which displays signi cant corrosion, while the GPU heat sink, indicated by Arrow 2, shows none.

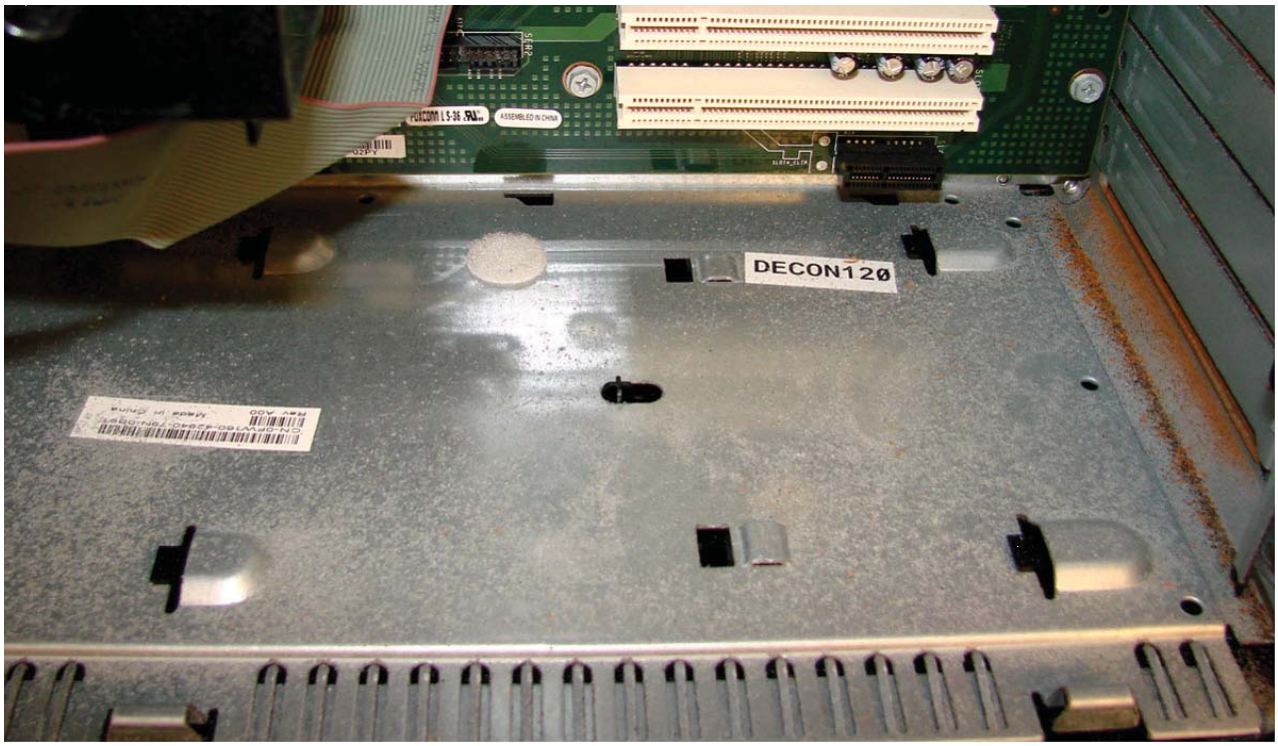
The powder covering the CPU heat sink was one of several types observed within the computer casing of all computers after ClO_2 fumigation. Figure 4-12 clearly shows at least two of the distinct powder types found (one white and one brown). Prior analysis by Alcatel-Lucent identi ed four prevalent types of corrosion particles present following ClO_2 fumigation. These particles contained aluminum and chlorine, aluminum and nickel, iron, or nickel, each combined with oxygen, carbon, and other elements. These particles are discussed in further detail in the Alcatel-Lucent CBRTA report.[16]

Because the PC-Doctor® testing protocol required opening the computer chassis, the dust inside the computer chassis presented a safety hazard to operators. The computers were placed on an anti-static mat within a hood and vacuumed during monthly PC-Doctor® tests. The cleaning operation may have improved the operation of the computers by removing hygroscopic particles that could have conducted or shorted any electrical components within the chassis.

Figure 4-12. Inside bottom of computer case exposed to ClO_2 showing two distinct powders produced by corrosion. White powder can be seen throughout the bottom, while rust-colored powder is seen primarily at the rear of the case (along right edge in this gure).
